Consulting, Resource, Education, Training, and Support Services for Home Inspectors  
"A candle loses no light when it lights another candle."

## **Exterior Deck Ledger Board Attachment and Inspection©**

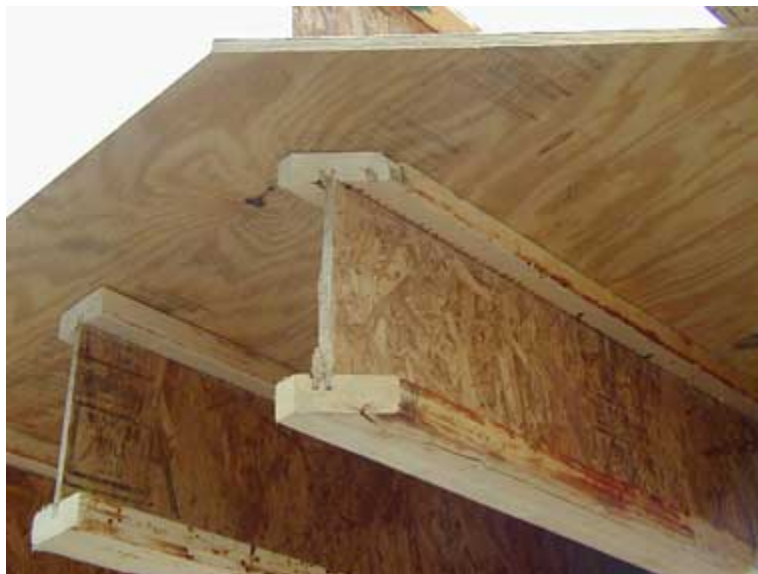
**Wood I Beams**

**The photographs on the following pages illustrate some of the engineered floor framing products used in the construction of residential floors.**

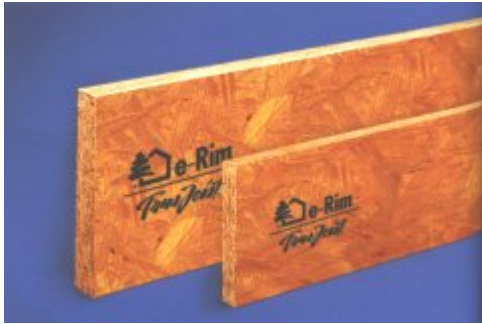
**Laminated Strand Lumber Rim Joists**  
Photo Courtesy of Weyerhaeuser

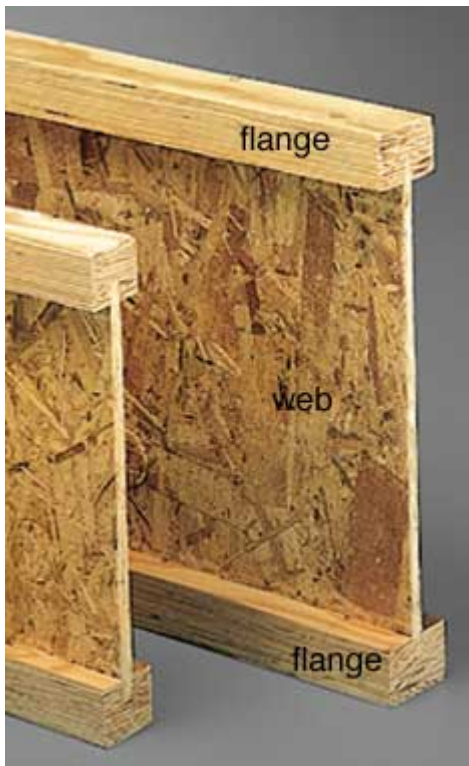
**Trus Joists® (TJIs)**  
Photo Courtesy of "This Old House"

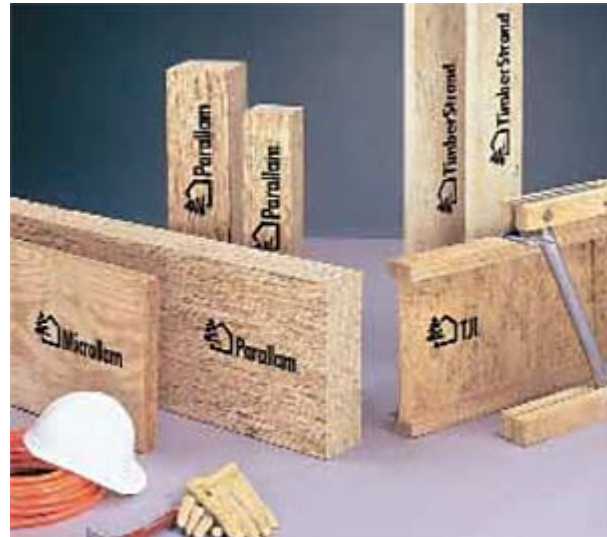
**Engineered lumber products**  
Photo Courtesy of Weyerhaeuser

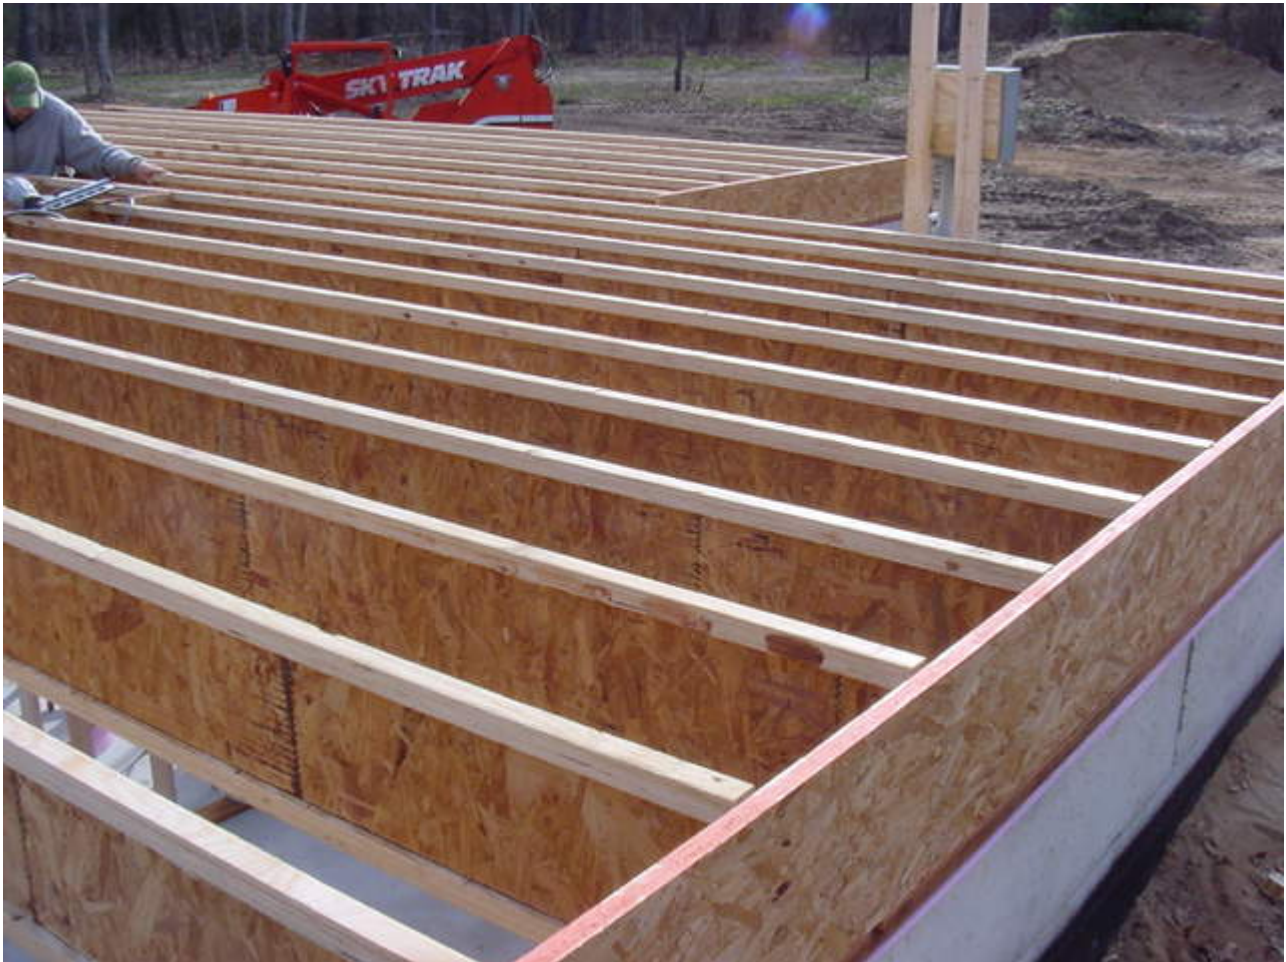
**Truss Joist Floor System with**

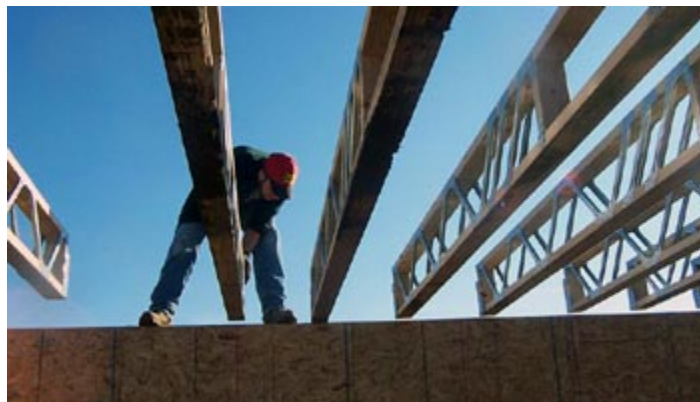
**Wood top and bottom chord/open metal web truss floor joists**  
Photo Courtesy Earthen Concepts & Developing

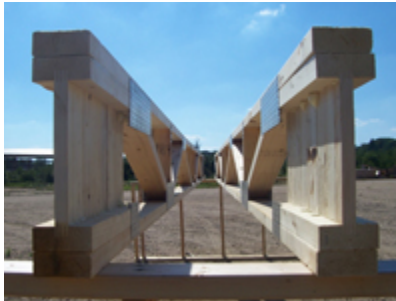
**EzyTrim parallel flat chord floor truss joists with trimmable ends**  
Photo Courtesy Kent Trusses Limited
