Galvanized Steel Potable Water Pipe

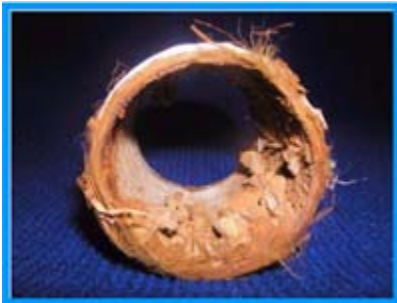
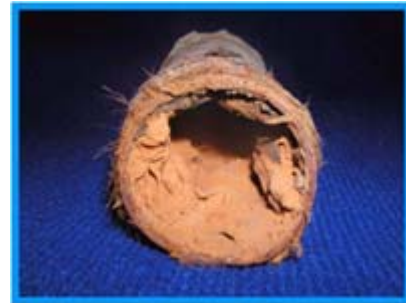
Two photos of corrosion on the interior of galvanized steel water pipe

The serviceable life of galvanized steel water piping varies from approximately thirty to sixty years depending on the composition (hardness) of the water and, to a lesser extent, the demands placed on the system. Over time, the normal processes of internal corrosion and mineral accretion or build-up on the inside of galvanized steel water piping will reduce its inside diameter and can result in reduction of water flow, damage to the internal components of valves, and clogging of shower heads and faucet aerators. In addition, an initial flow of rusty colored water may be discharged from water taps when they are first opened. Galvanized steel piping should not be connected to copper or brass piping materials or fittings without the use of dielectric couplings and fittings to reduce the potential for damage to the galvanized steel materials through the process of galvanic corrosion.

Indications that galvanized steel water pipe is approaching or at the end of its service life are: pinhole leaks or corrosion on the exterior surface of the pipe where pinhole leaks have temporarily self-sealed from mineral accretion/build-up, reduction in water flow, and/or the regular discharge of rusty colored water each time a tap is opened.
